**Flood Control Project Maintenance
Levee Inspections**

Maintenance Issue Types Only, Levee Inspection Report By Mile - Spring 2017

Reclamation District No. 0785 Driver

Waterway	Bank	Unit Miles	Inspection Start/End	Inspector
Unit No. 01 Sacramento River	Right	2.26	04/13/2017 04/13/2017	Zach Jojola

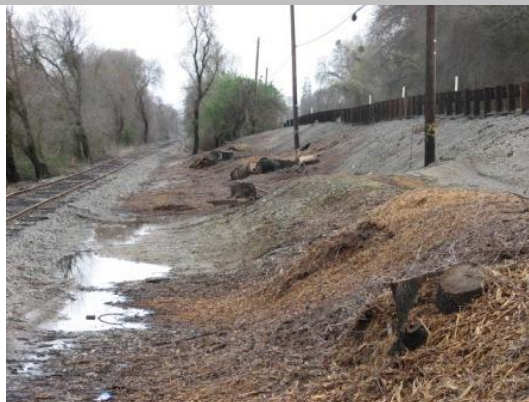
Photo 1 of 1 : SP_2017_RD0785_185_4_20170320_00003.jpg

LM Start	0.12	Rating **	N	Issue No.	4
LM End	1.34	Issue Type +	Ma	Location *	LS
Category	Earthen Levee			GPS Latitude/Longitude	
				Start	End
Item	Trim / Thin Trees			38.660160 °	38.646214 °
				-121.611619 °	-121.598596 °
DWR ID	DWR_RD0785_01_s_2012_4				
Comment Code					
T5 : Tree stumps.					
Inspector Comment

The trees were cut by PG&E'S tree contractor. The district will take care of the stumps in the future.

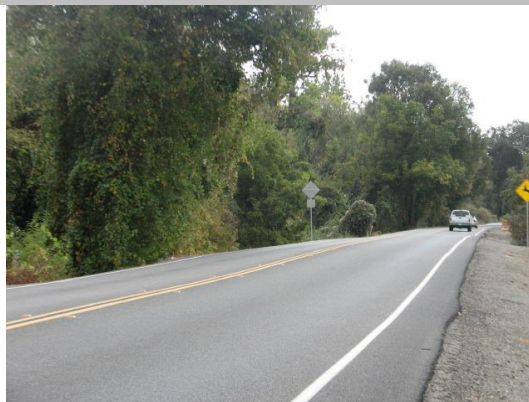
Photo 1 of 2 : SP_2017_RD0785_185_16_20170320_00013.jpg

Brush and other vegetation partially blocks visibility or access to the levee slope. Fall 2013

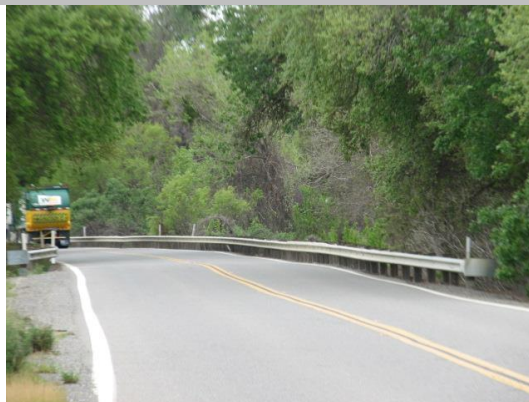
Photo 2 of 2 : SP_2017_RD0785_185_16_20170320_00014.jpg

Brush and other vegetation partially blocks visibility. Spring 2014

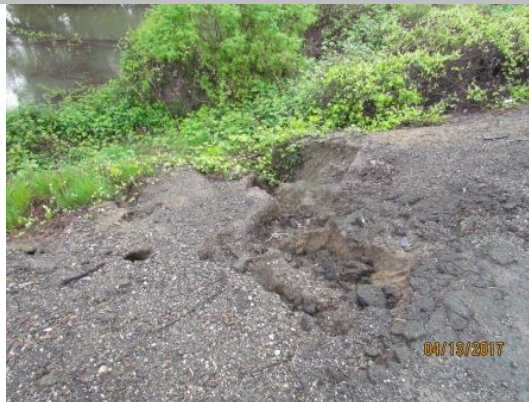
Photo 1 of 1 : SP_2017_RD0785_185_24_20170413_00065.jpg

LM Start	0.24	Rating **	U	Issue No.	24
LM End	0.24	Issue Type +	Ma	Location *	WS
Category	Earthen Levee			GPS Latitude/Longitude	
				Start	End
Item	Erosion / Bank Caving			38.658998 °	38.658998 °
				-121.610081 °	-121.610081 °
DWR ID	DWR_RD0785_01_s_2017_24				
Comment Code					
E2 : Schedule repair of erosion site prior to the next inspection.					
Inspector Comment					
Runoff erosion on waterside slope.

Runoff erosion on waterside levee slope. Spring 2017.

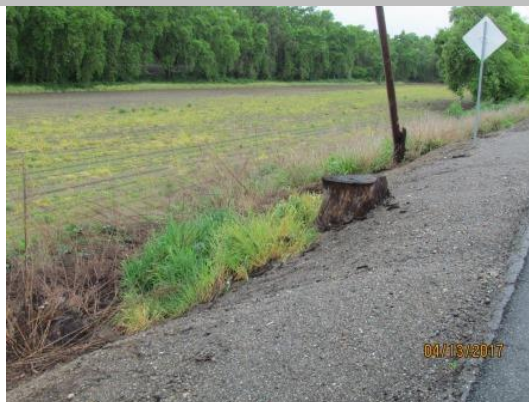
Photo 1 of 1 : SP_2017_RD0785_185_36_20170413_00066.jpg

LM Start	0.28	Rating **	N	Issue No.	36
LM End	0.28	Issue Type +	Ma	Location *	LS
Category	Earthen Levee			GPS Latitude/Longitude	
				Start	End
Item	Trim / Thin Trees			38.658537 °	38.658537 °
				-121.609675 °	-121.609675 °
DWR ID	DWR_RD0785_01_s_2017_36				
Comment Code					
T5 : Tree stumps.					
Inspector Comment

View of stump on landside levee slope. Spring 2017.

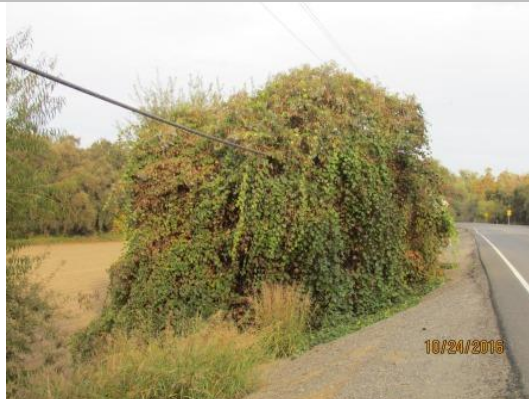
Photo 1 of 1 : SP_2017_RD0785_185_1_20170320_00001.jpg

Elderberry tree on LS slope. Fall 2016.

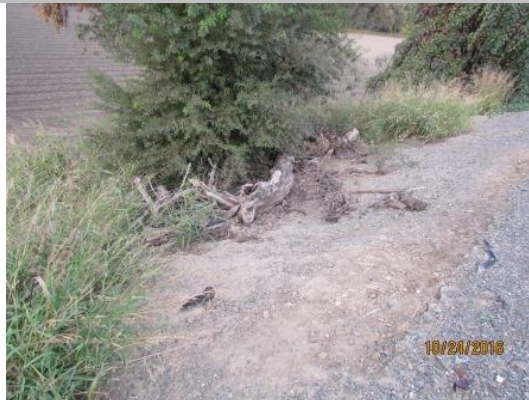
Photo 1 of 1 : SP_2017_RD0785_185_20_20170320_00015.jpg

LM Start	0.30	Rating **	M	Issue No.	20
LM End	0.30	Issue Type +	Ma	Location *	LS
Category	Earthen Levee			GPS Latitude/Longitude	
				Start	End
Item	Encroachments			38.658319 °	38.658319 °
				-121.609443 °	-121.609443 °
DWR ID	DWR_RD0785_01_f_2016_20				
Comment Code					
TR : Tree or limb					
Inspector Comment

View of a tree on LS slope. Fall 2016.

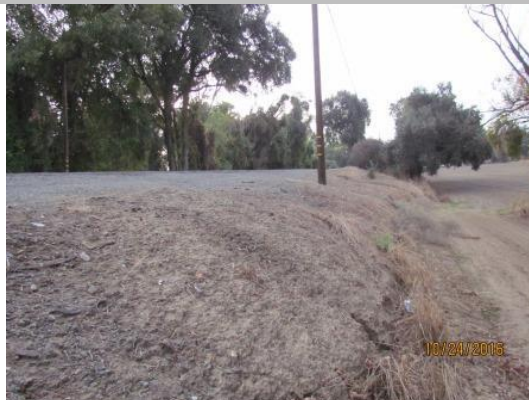
Photo 1 of 2 : SP_2017_RD0785_185_349_20170320_00050.jpg

LM Start	0.34	Rating **	M	Issue No.	349
LM End	0.34	Issue Type +	Ma	Location *	LS
Category	Earthen Levee			GPS Latitude/Longitude	
				Start	End
Item	Slope Stability			38.657798 °	38.657798 °
				-121.608898 °	-121.608898 °
DWR ID	DWR_RD0785_01_s_2015_349				
Comment Code					
S1 : Repair slope instability.					
Inspector Comment

An updated view of a slope stability issue on LS slope. Fall 2016.

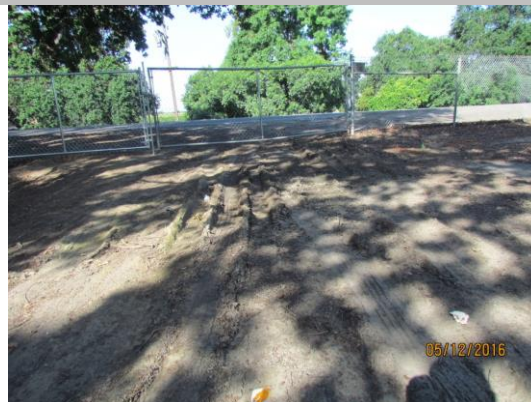
Photo 1 of 1 : SP_2017_RD0785_185_21_20170320_00016.jpg

LM Start	0.58	Rating **	M	Issue No.	21
LM End	0.58	Issue Type +	Ma	Location *	CR
Category	Earthen Levee			GPS Latitude/Longitude	
				Start	End
Item	Crown Surface / Depressions / Rutting			38.655077 °	38.655077 °
				-121.606237 °	-121.606237 °
DWR ID	DWR_RD0785_01_s_2016_21				
Comment Code					
C2 : Repair depressions or ruts in the crown or slope.					
Inspector Comment

View of the ruts on the crown of the levee. The direction of the river is upstream which is to the left of the picture. Spring 2016.

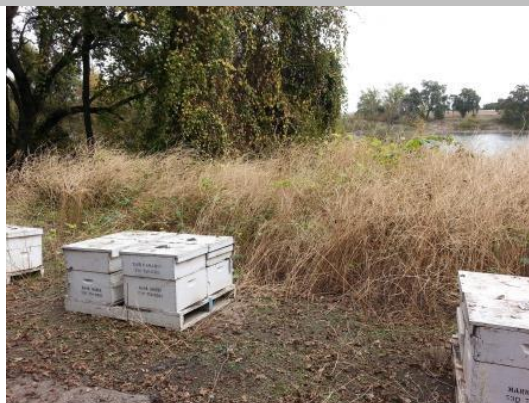
Photo 1 of 1 : SP_2017_RD0785_185_51_20170320_00047.jpg

View of vegetation site on WS slope. Fall 2016.

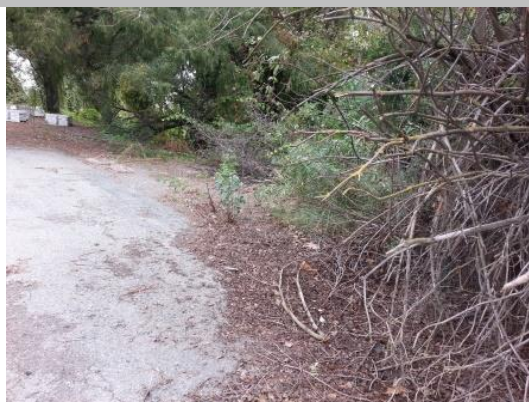
Photo 1 of 1 : SP_2017_RD0785_185_45_20170320_00040.jpg

LM Start	0.70	Rating **	M	Issue No.	45
LM End	0.73	Issue Type +	Ma	Location *	WS
Category	Earthen Levee			GPS Latitude/Longitude	
				Start	End
Item	Trim / Thin Trees			38.653882 °	38.653357 °
				-121.605007 °	-121.605043 °
DWR ID	DWR_RD0785_01_f_2016_45				
Comment Code					
T3 : Trim and thin trees to allow visibility of the ground and room to flood fight.					
Inspector Comment

View of a site where tree trimming is needed. Fall 2016.

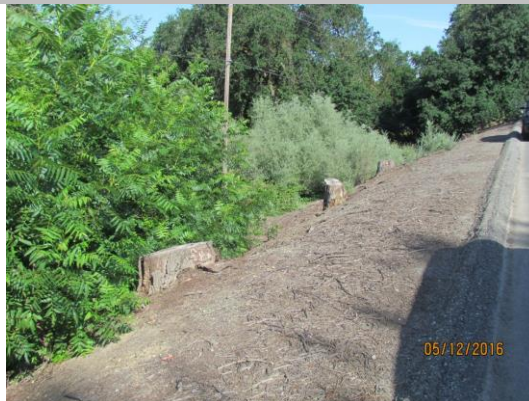
Photo 1 of 1 : SP_2017_RD0785_185_181_20170320_00048.jpg

View of the tree stumps on the landward side of the levee looking upstream. Spring 2016.

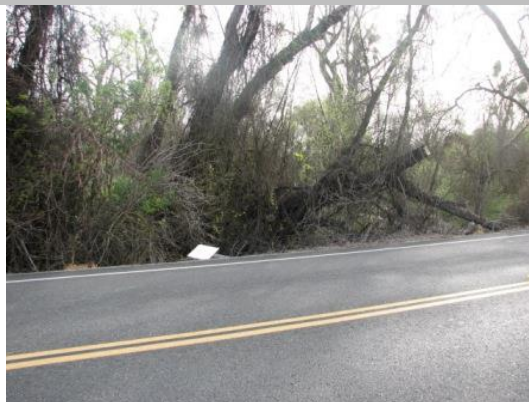
Photo 1 of 1 : SP_2017_RD0785_185_47_20170320_00042.jpg

The fallen tree and brush on the waterside of the roadway needs to be removed. Photo taken spring 2012.

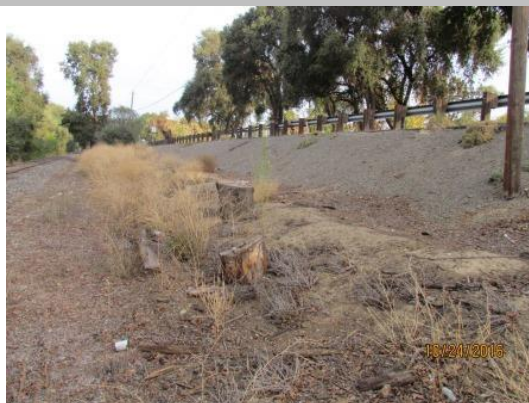
Photo 1 of 1 : SP_2017_RD0785_185_28_20170320_00022.jpg

Two decomposing tree stumps near levee toe on landside. Fall 2016.

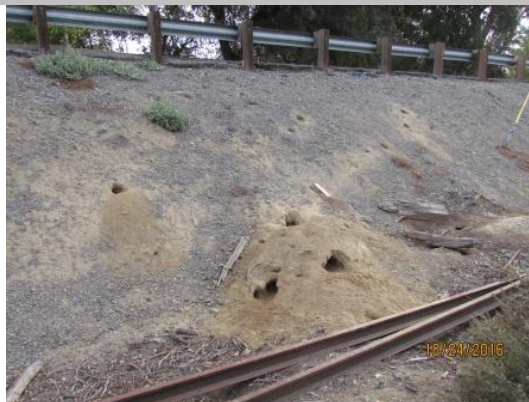
Photo 1 of 2 : SP_2017_RD0785_185_29_20170320_00023.jpg

LM Start	1.02	Rating **	U	Issue No.	29
LM End	1.02	Issue Type +	Ma	Location *	LS
Category	Earthen Levee			GPS Latitude/Longitude	
				Start	End
Item	Animal Control			38.649798 °	38.649798 °
				-121.602373 °	-121.602373 °
DWR ID	DWR_RD0785_01_f_2016_29				
Comment Code					
A3 : No rodents visible, but rodent burrows visible; need to backfill and compact or grout burrows.					
Inspector Comment					
Large rodent holes with more than 2 cu.ft of soil around

View of rodent holes on LS slope. Fall 2016.

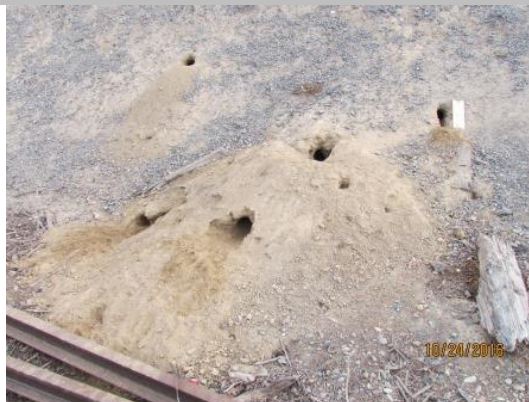
Photo 2 of 2 : SP_2017_RD0785_185_29_20170320_00024.jpg

Another view of rodent holes. Fall 2016.

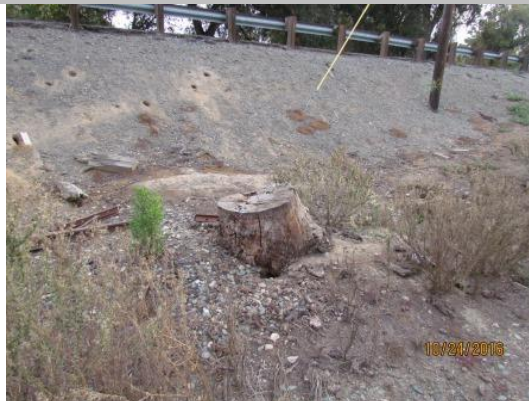
Photo 1 of 1 : SP_2017_RD0785_185_30_20170320_00025.jpg

View of a decomposing stump near levee toe on landside. Fall 2016.

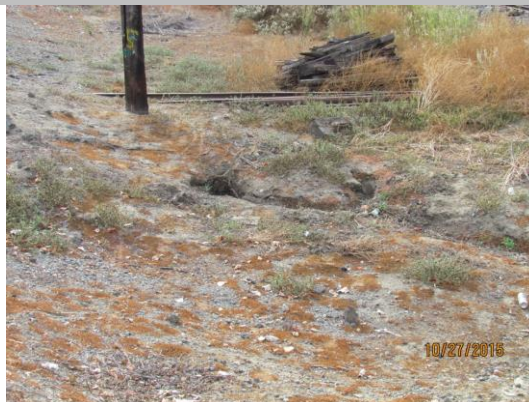
Photo 1 of 3 : SP_2017_RD0785_185_48_20170320_00043.jpg

LM Start	1.07	Rating **	M	Issue No.	48
LM End	1.07	Issue Type +	Ma	Location *	LS
Category	Earthen Levee			GPS Latitude/Longitude	
				Start	End
Item	Erosion / Bank Caving			38.649392 °	38.649392 °
				-121.601636 °	-121.601636 °
DWR ID	DWR_RD0785_01_s_2012_48				
Comment Code					
E2 : Schedule repair of erosion site prior to the next inspection.					
Inspector Comment

View of the erosion at the toe of the levee on the landward side of the levee looking downstream. Fall 2015.

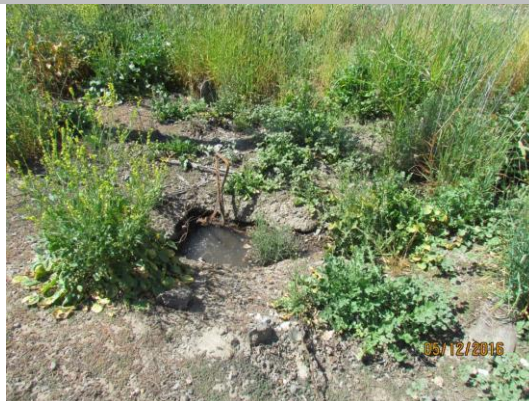
Photo 2 of 3 : SP_2017_RD0785_185_48_20170320_00044.jpg

LM Start	1.07	Rating **	M	Issue No.	48 (cont)	
LM End	1.07	Issue Type +	Ma	Location *	LS	
Category	Earthen Levee			GPS Latitude/Longitude		
				Start		End
Item	Erosion / Bank Caving			38.649392 °		38.649392 °
				-121.601636 °		-121.601636 °
DWR ID	DWR_RD0785_01_s_2012_48					
Comment Code						
E2 : Schedule repair of erosion site prior to the next inspection.						
Inspector Comment

Drain pipe is causing erosion on the landward side of the levee between the Isope and railroad tracks. Spring 2016.

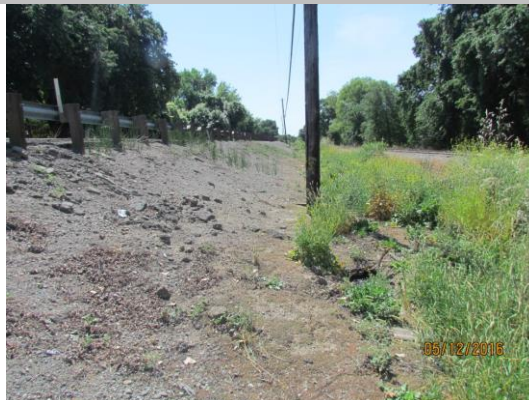
Photo 3 of 3 : SP_2017_RD0785_185_48_20170320_00045.jpg

Perspective view of the erosion on the landward side of the levee looking downstream. Spring 2016.

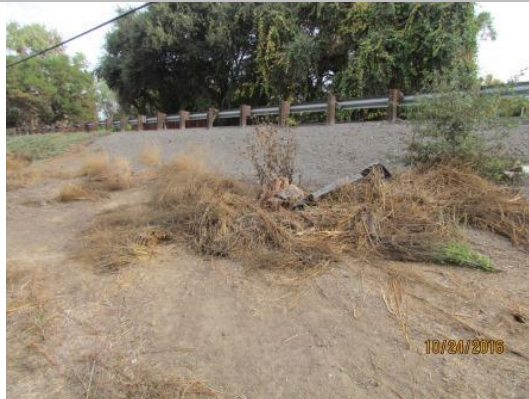
Photo 1 of 1 : SP_2017_RD0785_185_31_20170320_00026.jpg

Decomposing tree stump near levee toe on landside. Fall 2016.

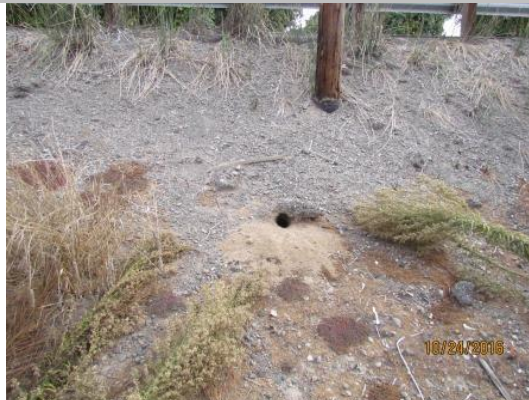
Photo 1 of 1 : SP_2017_RD0785_185_32_20170320_00027.jpg

View of rodent hole on LS slope. Fall 2016.

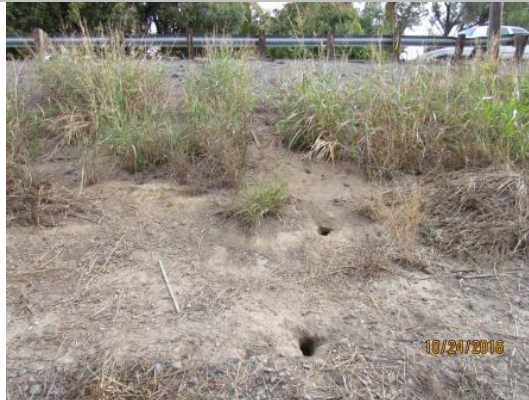
Photo 1 of 1 : SP_2017_RD0785_185_33_20170320_00028.jpg

View of rodent holes on LS slope. Fall 2016.

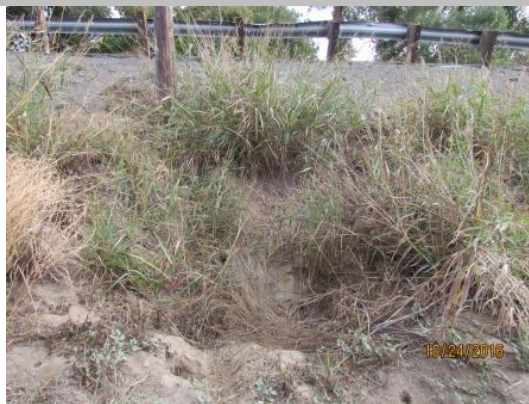
Photo 1 of 2 : SP_2017_RD0785_185_34_20170320_00029.jpg

LM Start	1.17	Rating **	U	Issue No.	34
LM End	1.17	Issue Type +	Ma	Location *	LS
Category	Earthen Levee			GPS Latitude/Longitude	
				Start	End
Item	Erosion / Bank Caving			38.648090 °	38.648090 °
				-121.600650 °	-121.600650 °
DWR ID	DWR_RD0785_01_f_2016_34				
Comment Code					
E2 : Schedule repair of erosion site prior to the next inspection.					
Inspector Comment					
LS slope erosion at pipe crossing. Pipe is not found in UCIP inventory.

Erosion of LS slope approximately above a steel pipe. Fall 2016.

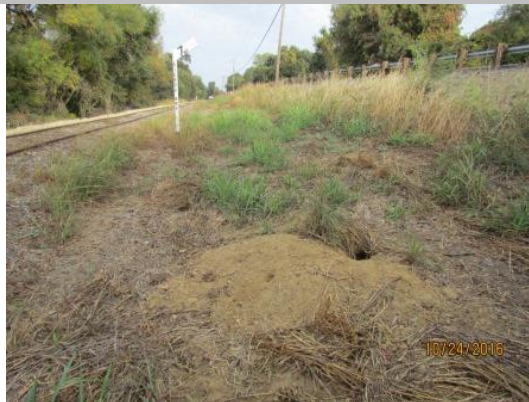
Photo 1 of 1 : SP_2017_RD0785_185_37_20170320_00032.jpg

View of a rodent hole on landward side of the levee. Fall 2016.

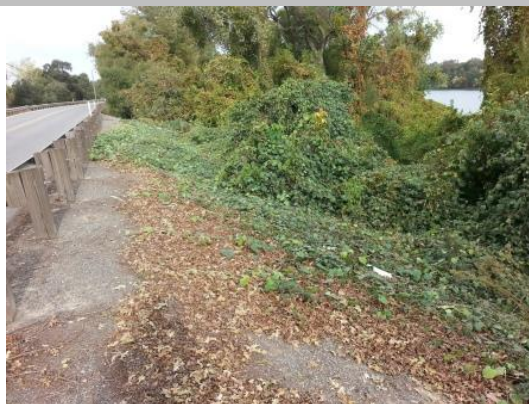
Photo 1 of 2 : SP_2017_RD0785_185_44_20170320_00038.jpg

Elderberry trees on WS slope Fall 2016.

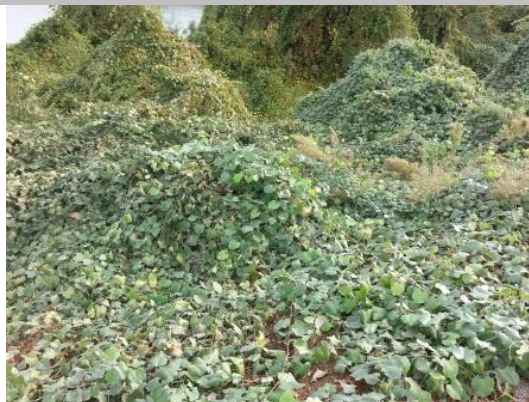
Photo 2 of 2 : SP_2017_RD0785_185_44_20170320_00039.jpg

Elderberry trees on WS slope. Fall 2016.

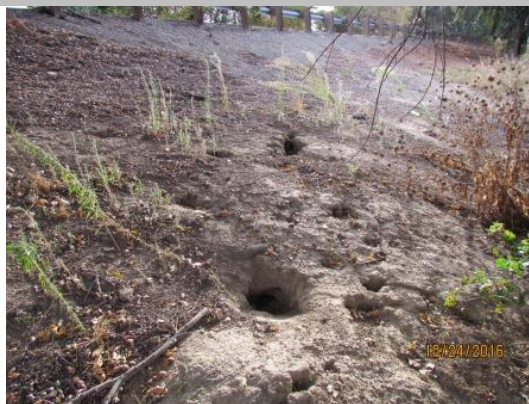
Photo 1 of 1 : SP_2017_RD0785_185_35_20170320_00031.jpg

View of rodent holes on LS slope. Fall 2016.

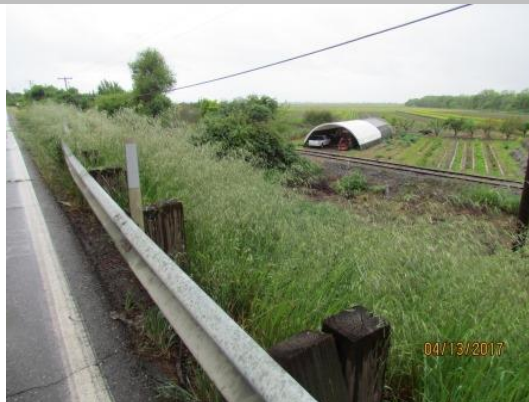
Photo 1 of 1 : SP_2017_RD0785_185_55_20170413_00067.jpg

Tall vegetation on landside levee slope, blocking visibility. Spring 2017.

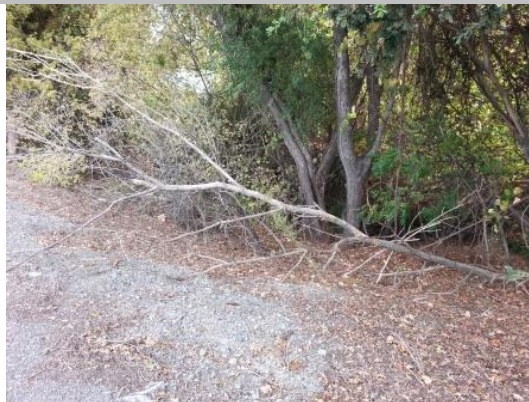
Photo 1 of 1 : SP_2017_RD0785_185_43_20170320_00037.jpg

View of fallen tree on WS slope. Fall 2016.

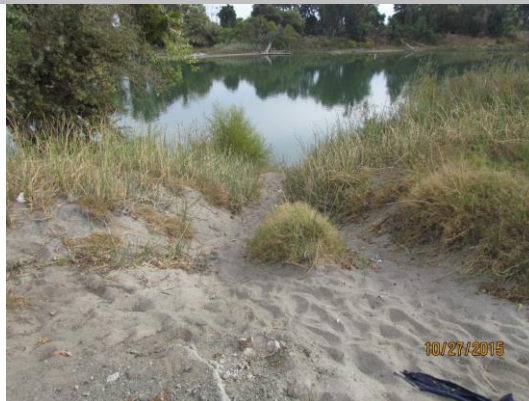
Photo 3 of 3 : SP_2017_RD0785_185_13_20170320_00010.jpg

LM Start	1.31	Rating **	M	Issue No.	13 (cont)	
LM End	1.31	Issue Type +	Ma	Location *	WS	
Category	Earthen Levee			GPS Latitude/Longitude		
				Start		End
Item	Slope Stability			38.646671 °		38.646671 °
				-121.598915 °		-121.598915 °
DWR ID	DWR_RD0785_01_s_2013_13					
Comment Code						
S2 : Repair the levee slope damaged by foot traffic and prevent access where possible.						
Inspector Comment

View of the slope stability on the waterward side of the levee. Fall 2015.

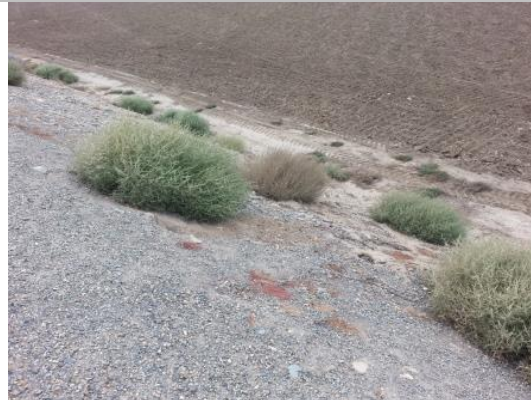
Photo 1 of 1 : SP_2017_RD0785_185_38_20170320_00033.jpg

Rodent holes on LS slope. Fall 2016.

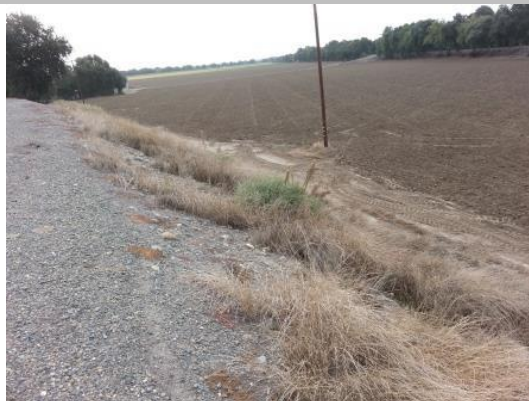
Photo 1 of 1 : SP_2017_RD0785_185_39_20170320_00034.jpg

View of vegetation of LS slope. Fall 2016.

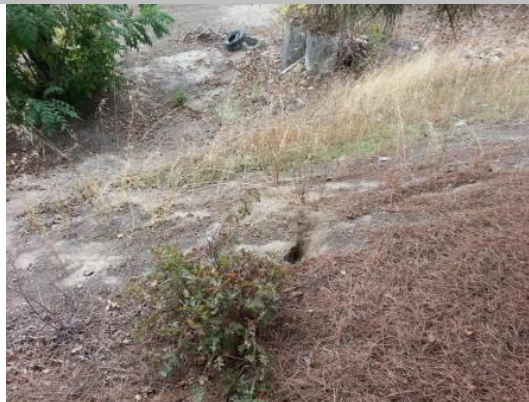
Photo 1 of 1 : SP_2017_RD0785_185_40_20170320_00035.jpg

Rodent burrows on LS slope of the levee. Fall 2016.

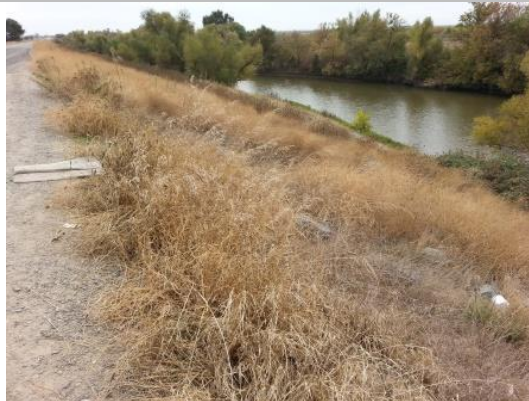
Photo 1 of 1 : SP_2017_RD0785_186_5_20170320_00001.jpg

View of vegetation on WS slope. Unable to see through vegetation. Fall 2016.

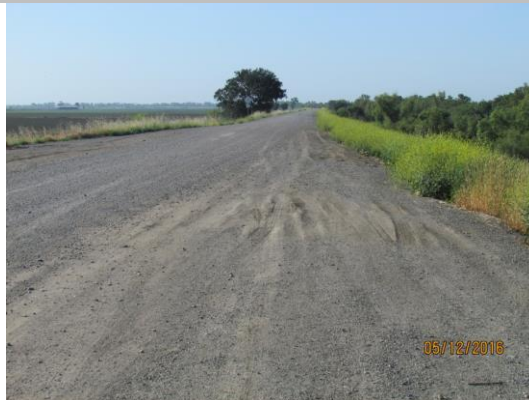
Photo 1 of 1 : SP_2017_RD0785_186_8_20170320_00004.jpg

LM Start	0.01	Rating **	M	Issue No.	8
LM End	0.01	Issue Type +	Ma	Location *	CR
Category	Earthen Levee			GPS Latitude/Longitude	
				Start	End
Item	Crown Surface / Depressions / Rutting			38.641105 °	38.641105 °
				-121.620402 °	-121.620402 °
DWR ID	DWR_RD0785_02_s_2016_8				
Comment Code					
C2 : Repair depressions or ruts in the crown or slope.					
Inspector Comment

View of the ruts on the crown of the levee looking downstream. Spring 2016.

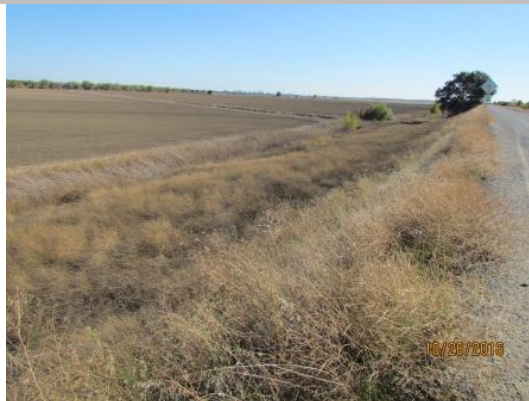
Photo 1 of 1 : SP_2017_RD0785_186_6_20170320_00002.jpg

View of dense vegetation on landside slope. Fall 2016.

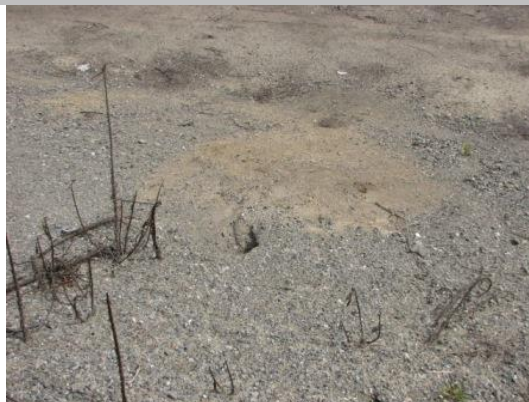
Photo 1 of 1 : SP_2017_RD0785_186_25_20170320_00015.jpg

Rodent holes on the landside levee slope, photo taken spring 2012.

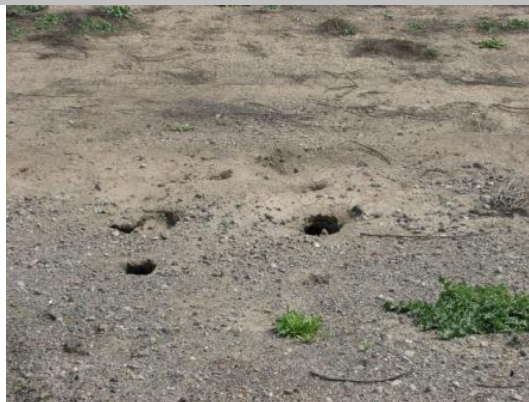
Photo 1 of 1 : SP_2017_RD0785_186_27_20170320_00016.jpg

Rodent holes on the landside levee slope, photo taken spring 2012.

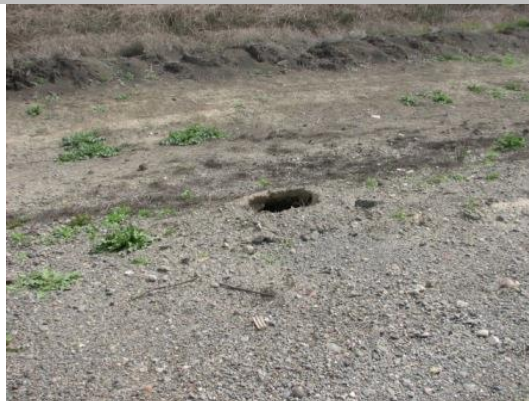
Photo 1 of 2 : SP_2017_RD0785_186_28_20170320_00017.jpg

Many rodent holes with in 25' of each other, photo taken spring 2012.

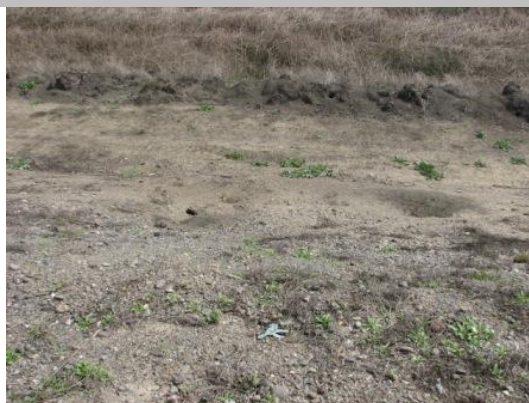
Photo 2 of 2 : SP_2017_RD0785_186_28_20170320_00018.jpg

Rodent holes on the landside levee slope, photo taken spring 2012.

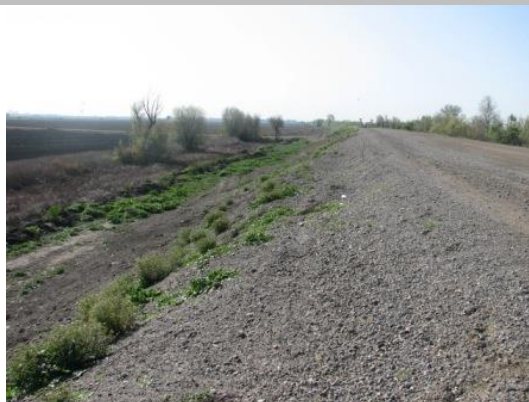
Photo 1 of 2 : SP_2017_RD0785_186_29_20170320_00019.jpg

LM Start	0.54	Rating **	M	Issue No.	29
LM End	0.54	Issue Type +	Ma	Location *	LS
Category	Earthen Levee			GPS Latitude/Longitude	
				Start	End
Item	Slope Stability			38.634130 °	38.634130 °
				-121.616130 °	-121.616130 °
DWR ID	DWR_RD0785_02_s_2012_29				
Comment Code					
S1 : Repair slope instability.					
Inspector Comment

Slope instability at shoulder of landside levee bulge at toe.

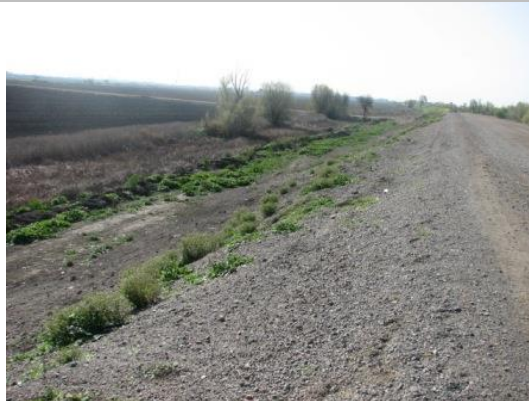
Photo 2 of 2 : SP_2017_RD0785_186_29_20170320_00020.jpg

LM Start	0.54	Rating **	M	Issue No.	29 (cont)	
LM End	0.54	Issue Type +	Ma	Location *	LS	
Category	Earthen Levee			GPS Latitude/Longitude		
				Start		End
Item	Slope Stability			38.634130 °		38.634130 °
				-121.616130 °		-121.616130 °
DWR ID	DWR_RD0785_02_s_2012_29					
Comment Code						
S1 : Repair slope instability.						
Inspector Comment

Bulge at the landside toe of the levee, photos taken spring 2012.

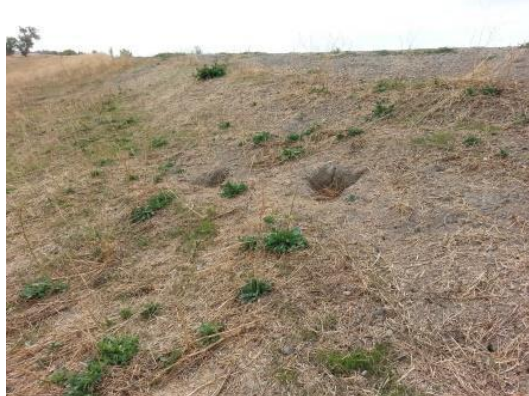
Photo 1 of 2 : SP_2017_RD0785_186_42_20170320_00026.jpg

View of rodent holes on LS slope. Holes are partially filled with soil and dry weeds/ grass. No evidence of rodent activity. Fall 2016.

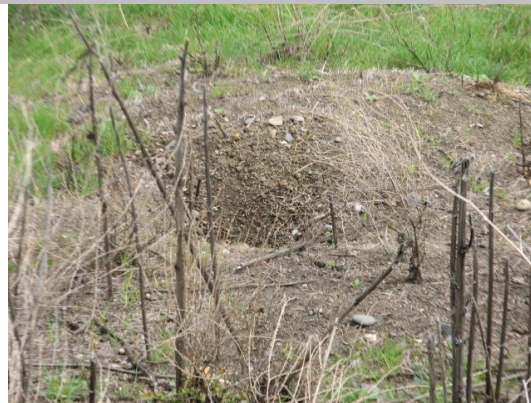
Photo 2 of 2 : SP_2017_RD0785_186_42_20170320_00027.jpg

Large rodent hole close to the toe of the levee. Spring 2014

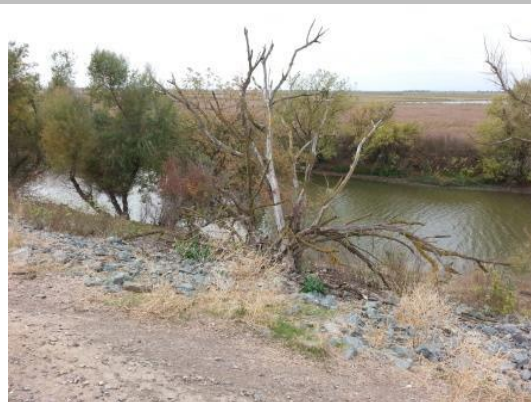
Photo 1 of 1 : SP_2017_RD0785_186_13_20170320_00010.jpg

View of dry tree on waterward slope. Fall 2016.

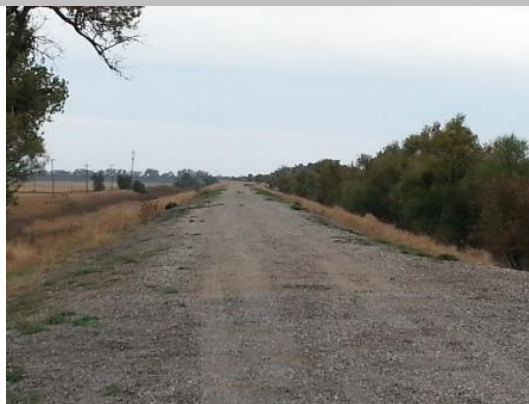
Photo 1 of 1 : SP_2017_RD0785_186_14_20170320_00011.jpg

Ruts on the crown. Fall 2016.

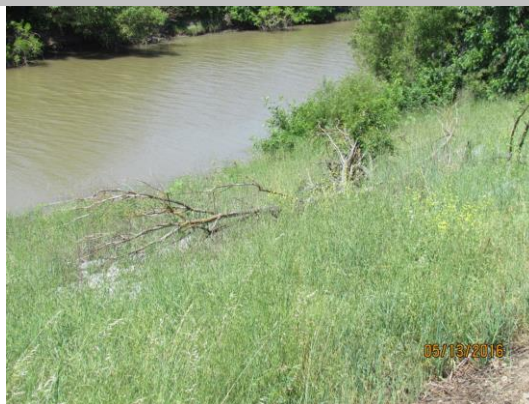
Photo 1 of 2 : SP_2017_RD0785_186_10_20170320_00007.jpg

Discarded tree is on the waterward slope of the levee. Spring 2016.

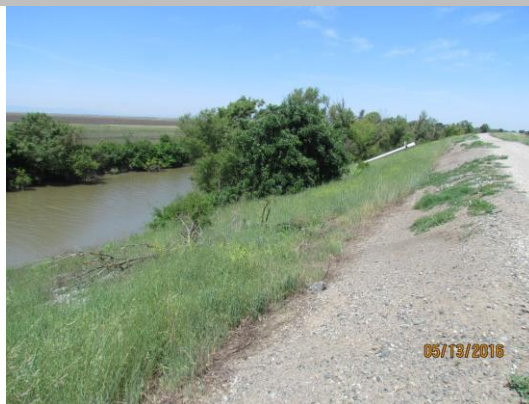
Photo 2 of 2 : SP_2017_RD0785_186_10_20170320_00008.jpg

Perspective view of the discarded tree looking upstream. Spring 2016.

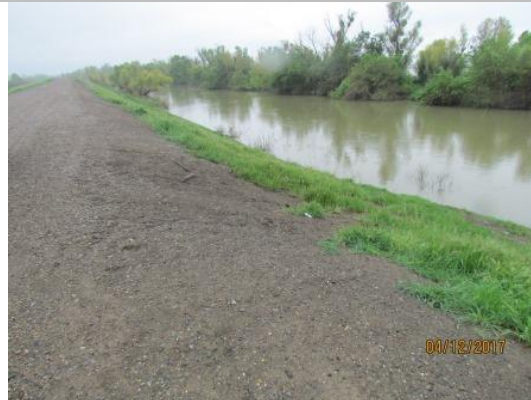
Photo 1 of 1 : SP_2017_RD0785_186_24_20170413_00034.jpg

View of slope stability on waterside levee slope. Spring 2017.

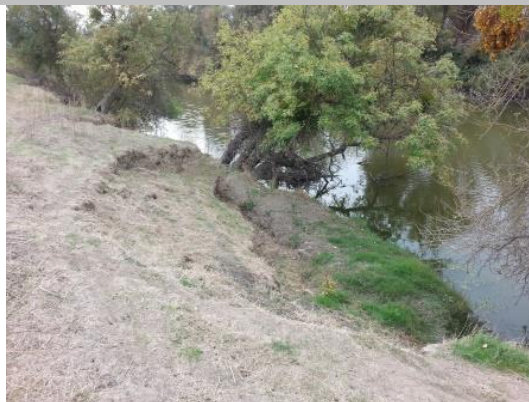
Photo 1 of 1 : SP_2017_RD0785_186_17_20170320_00012.jpg

View of erosion site on waterward side of the levee. Fall 2016.

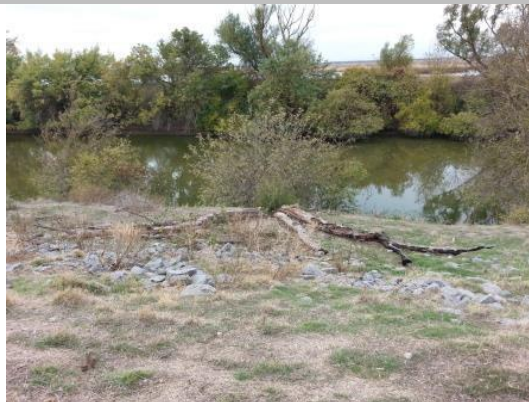
Photo 1 of 3 : SP_2017_RD0785_186_56_20170320_00028.jpg

Updated view of a tree on waterward side of the levee. Fall 2016.

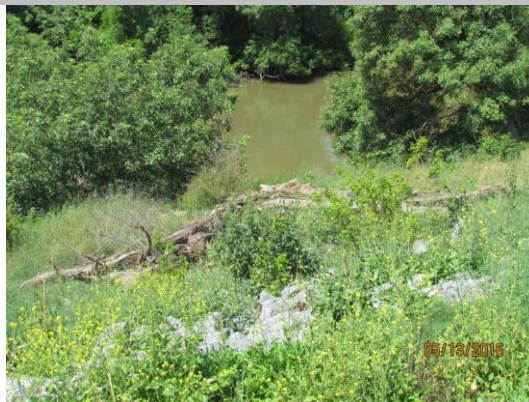
Photo 2 of 3 : SP_2017_RD0785_186_56_20170320_00029.jpg

Discarded tree is on the slope of the waterward side of the levee. Spring 2016.

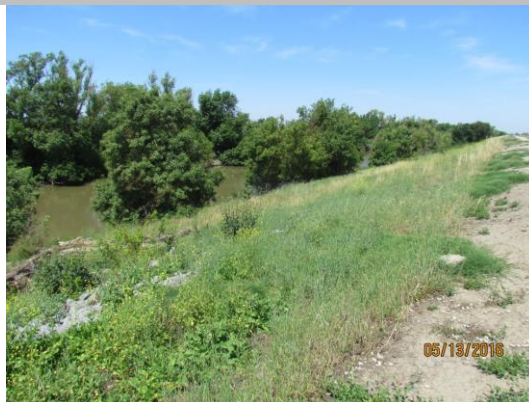
Photo 3 of 3 : SP_2017_RD0785_186_56_20170320_00030.jpg

Perspective view of the tree looking upstream. Spring 2016.
